**AMERICUS AVENUE DRAIN PIPE
INSPECTION AND REPAIR INFORMATION**

**GULF COUNTY BOARD OF COUNTY COMMISSIONERS
1000 CECIL G. COSTIN SR. BLVD.
PORT ST. JOE, FLORIDA 32456**

PROJECT NUMBER 3.181

Americus Ave. Drain Pipe Inspection and Repair Information

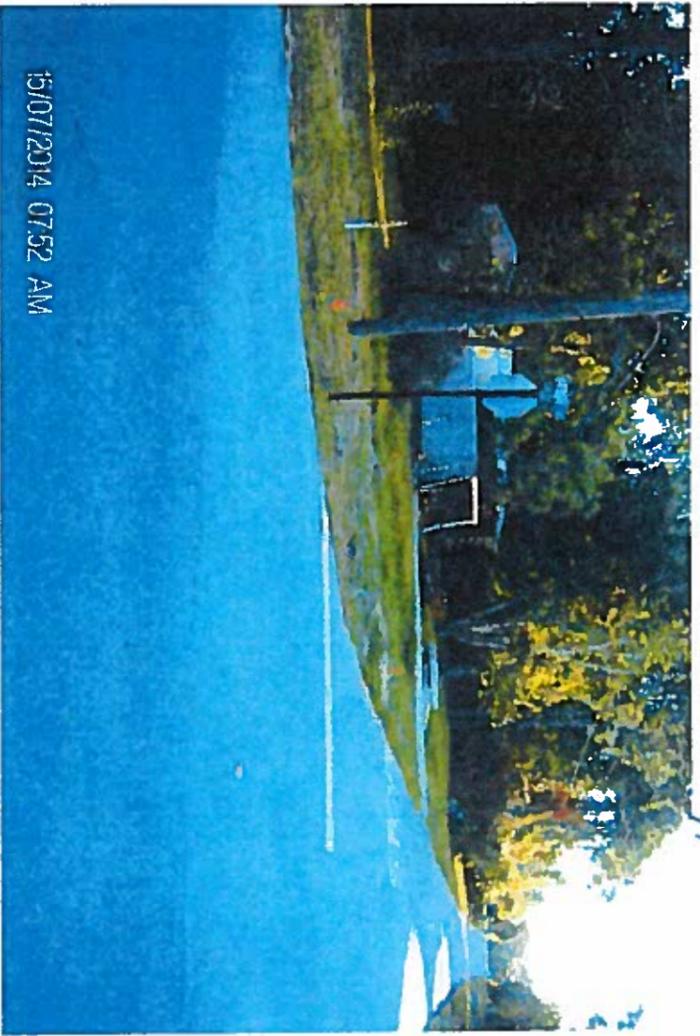
Location #1 - Northeast corner of Cortez and Americus. Prior to excavation.

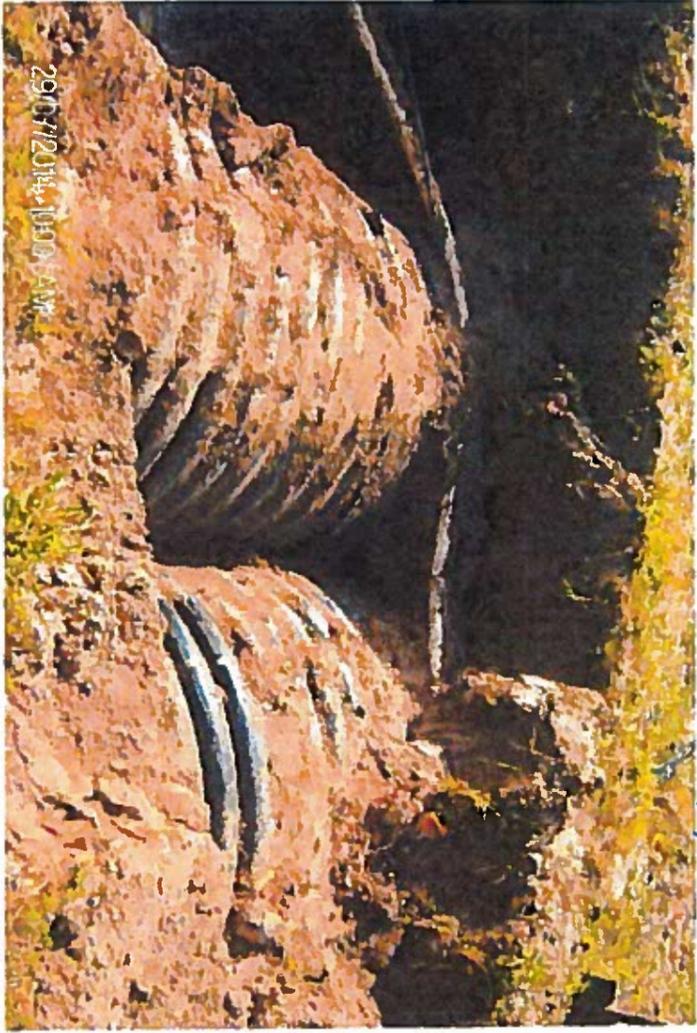
Location #1 - 48" ADS pipes looking towards Cortez.

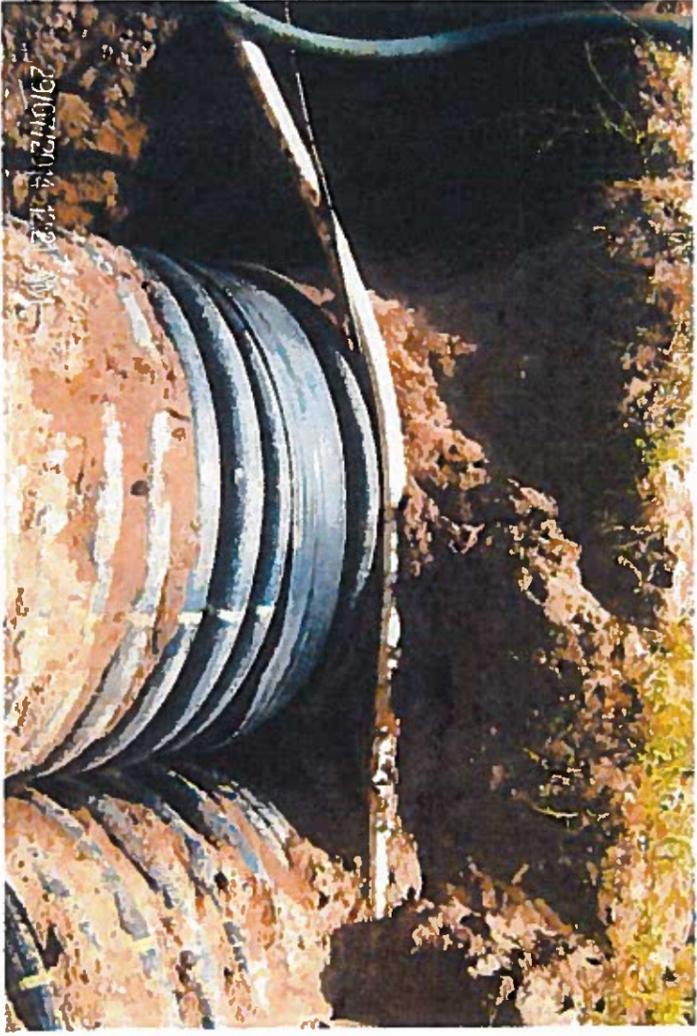
Location #1 - misaligned joint on eastern most 48" pipe.

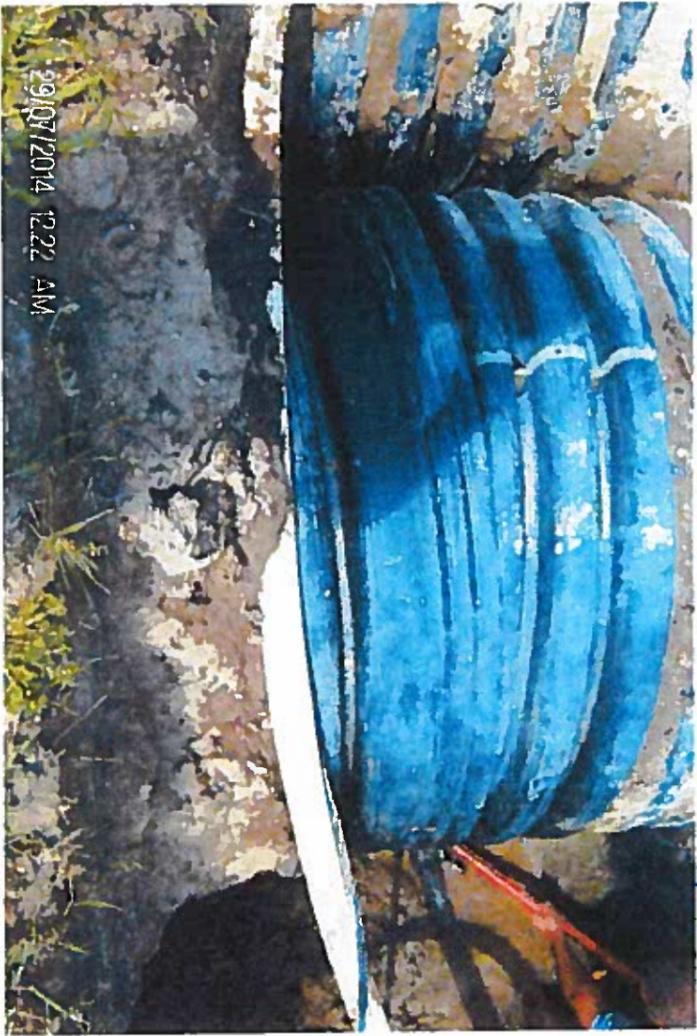
Location #1 - top view of misaligned joint on eastern most 48" pipe.

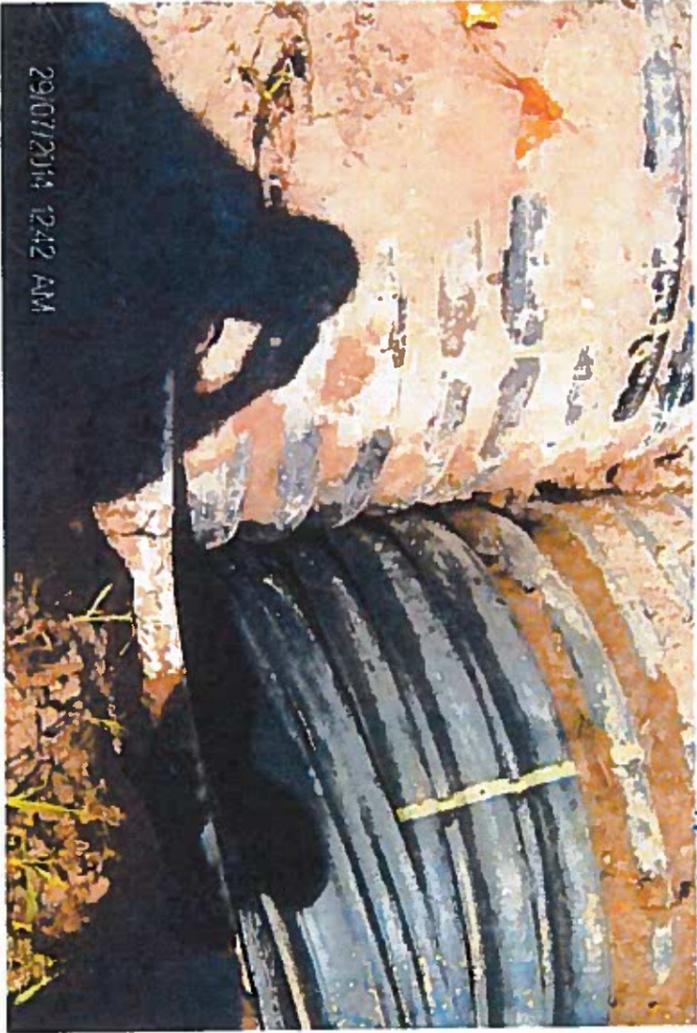
Location #1 - top view of misaligned joint on eastern most 48" pipe.

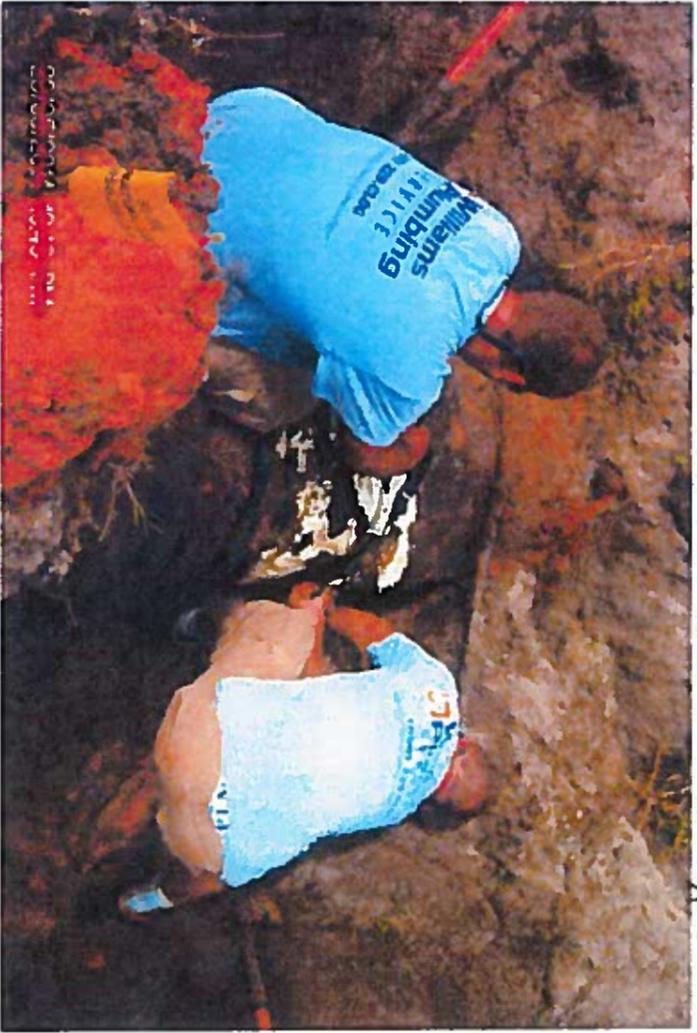
Location #2 - 24" cross drain between Cortez & Desoto. Beginning excavation.

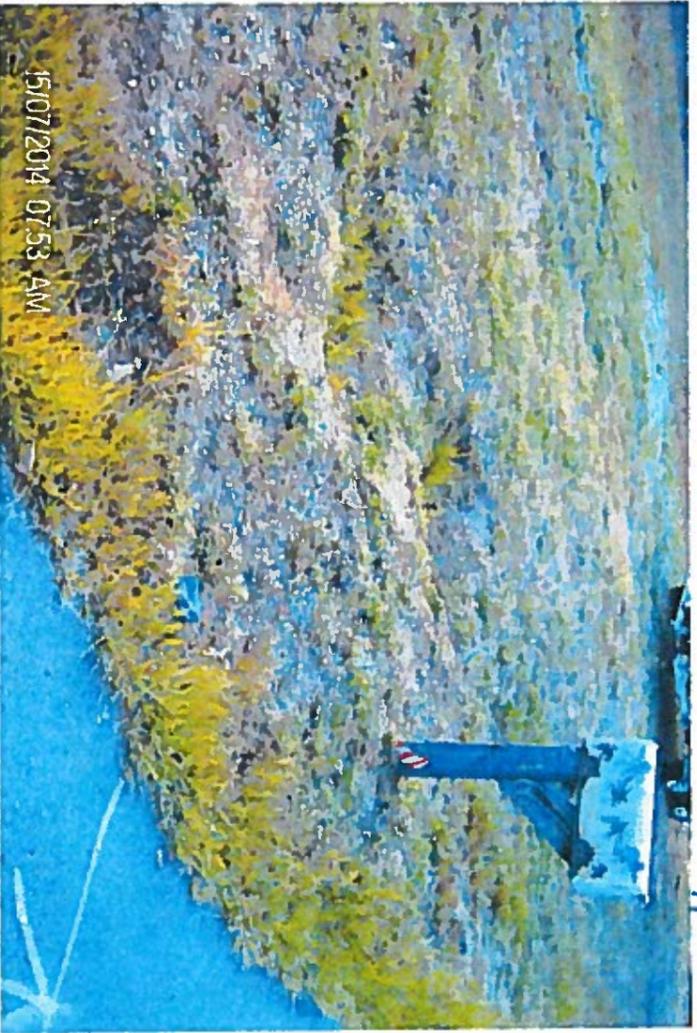
Location #3 - 7466 Americus Avenue between Desoto and Columbus. Prior to excavation.

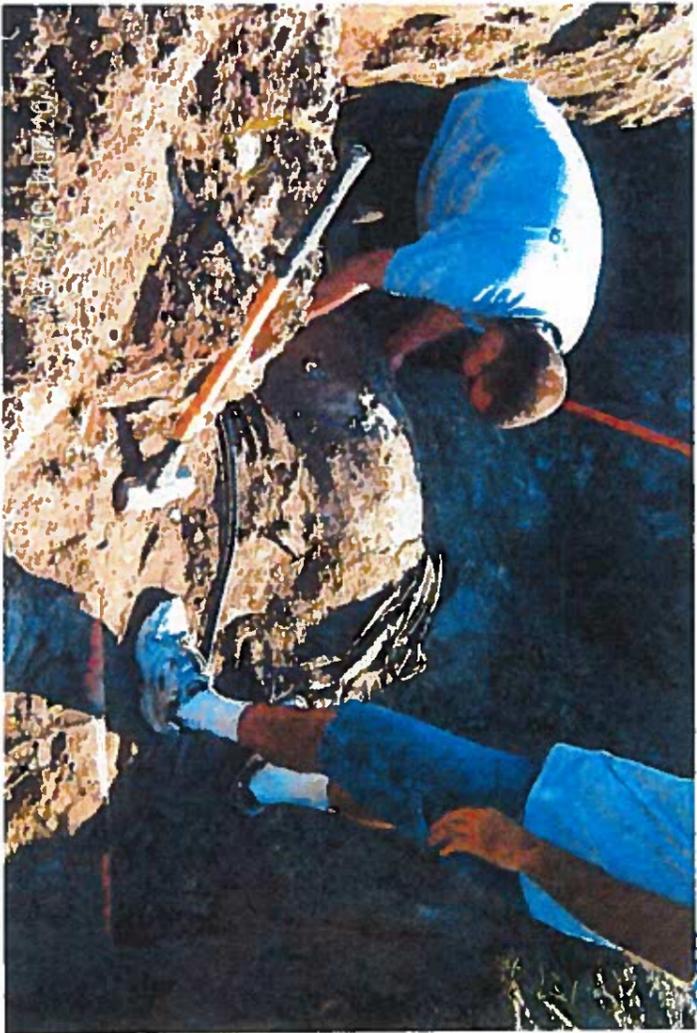
Location #3 - beginning excavation. 24" pipe had a small amount of concrete installed over filter fabric.

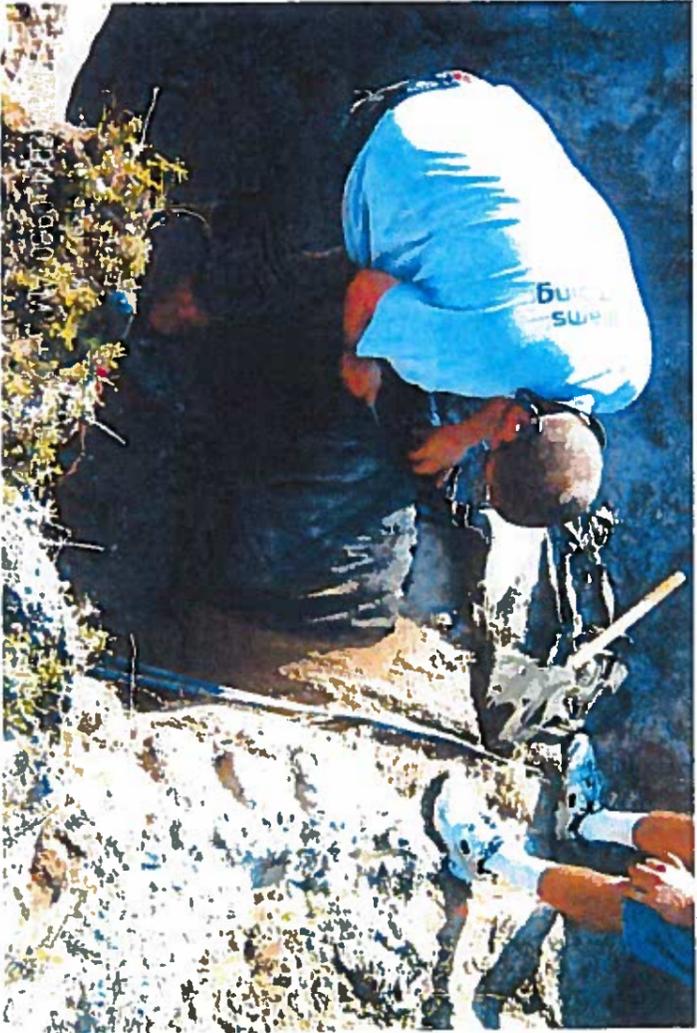
Location #3 - 24" ADS to 24" RCP connection. Removing filter fabric.

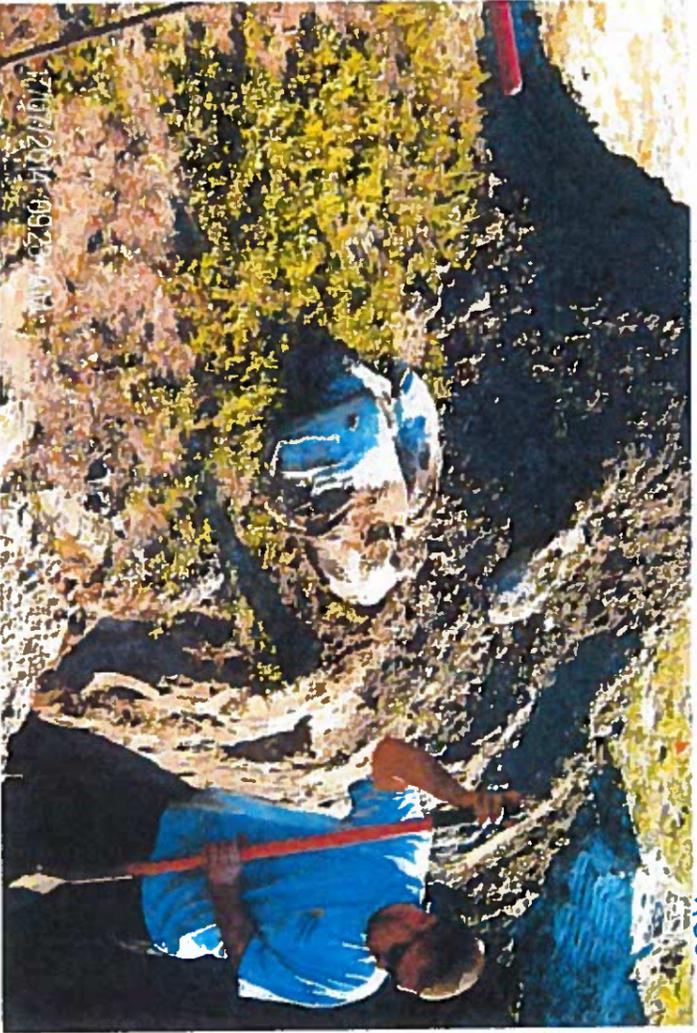
Location #3 - Approximately ten (10) sandbags removed from joint area. Appear to have been used to form concrete patch at the ADS to RCP connection.

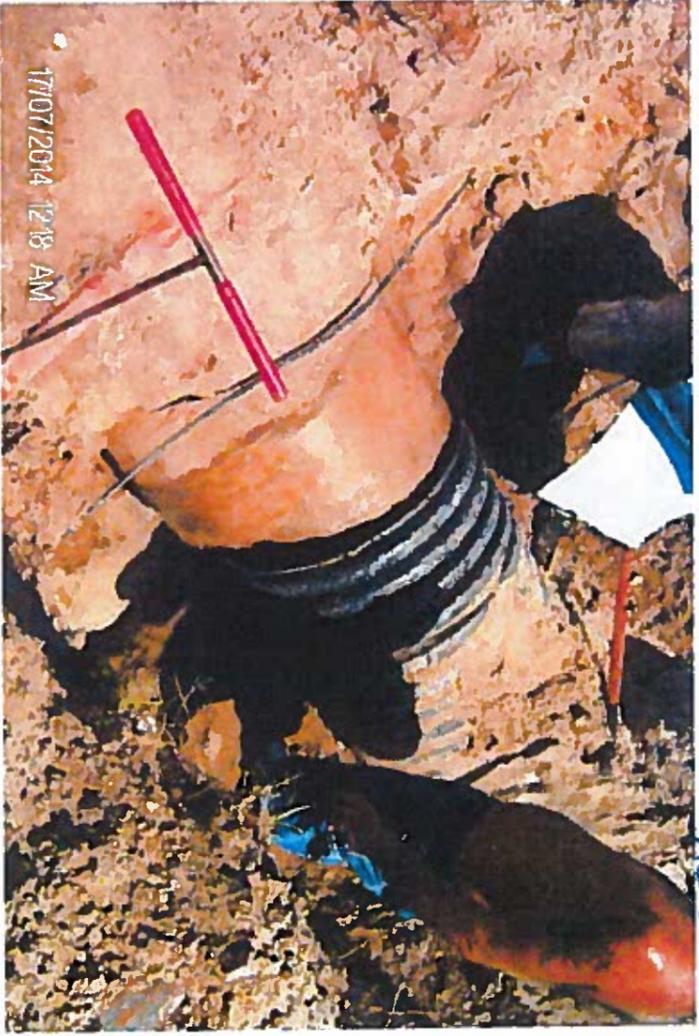
Location #3 - existing material removed and existing pipes exposed. The end of the RCP was broken.

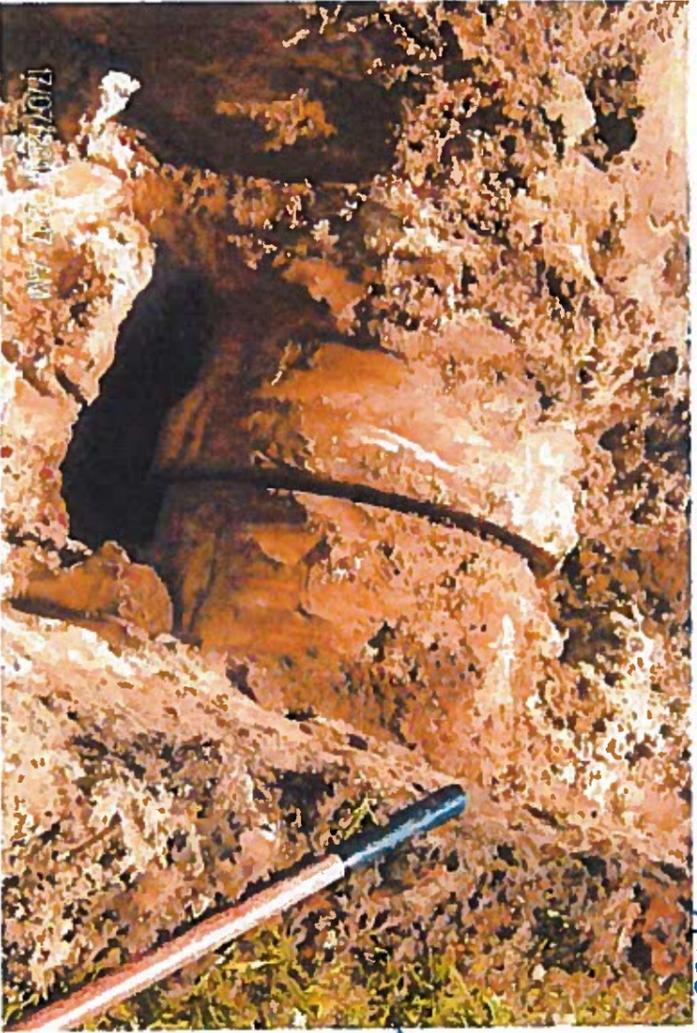
Location #3 - Exposed the RCP joint closer to Americus Avenue to check for integrity.
No visible issues found.

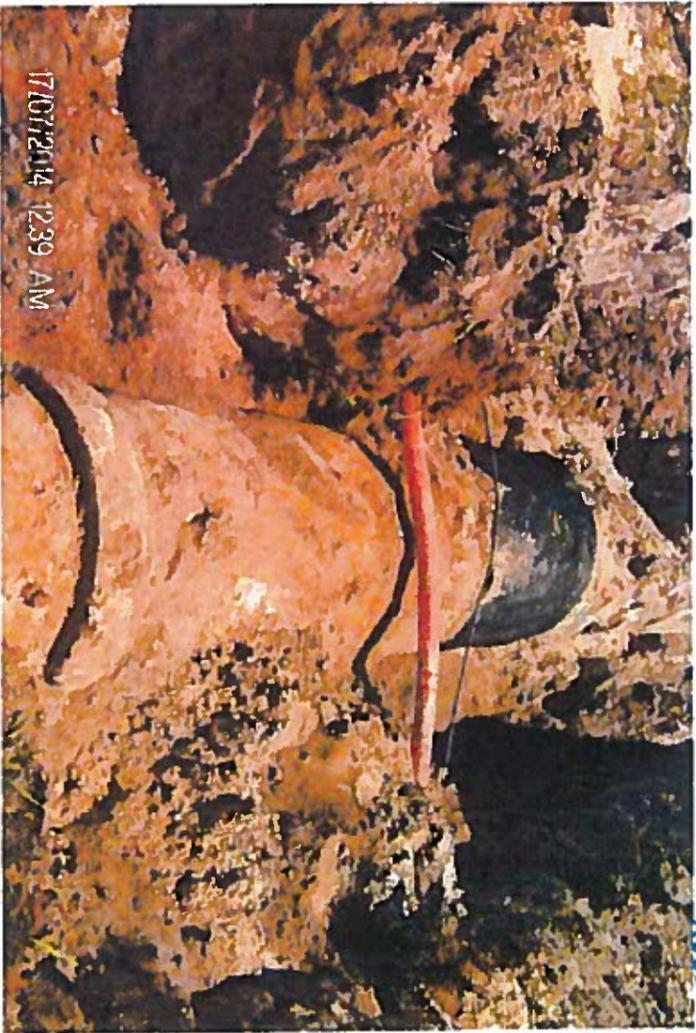
Location #3 - Looking east from Americus Avenue showing repaired ADS to RCP connection and RCP joint that had no visual issues. Fiber optic line (orange conduit) and Mediacom cable (black cable) also shown.

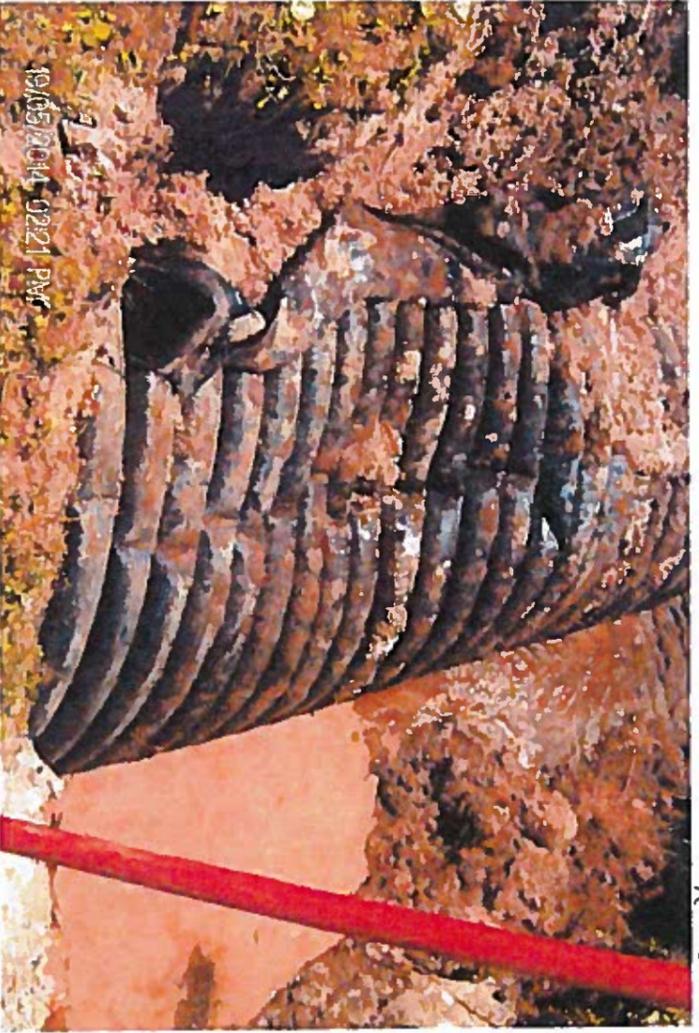
Location #4 - Between Balboa & Magellan. Existing pipe damaged just before and near joint location.

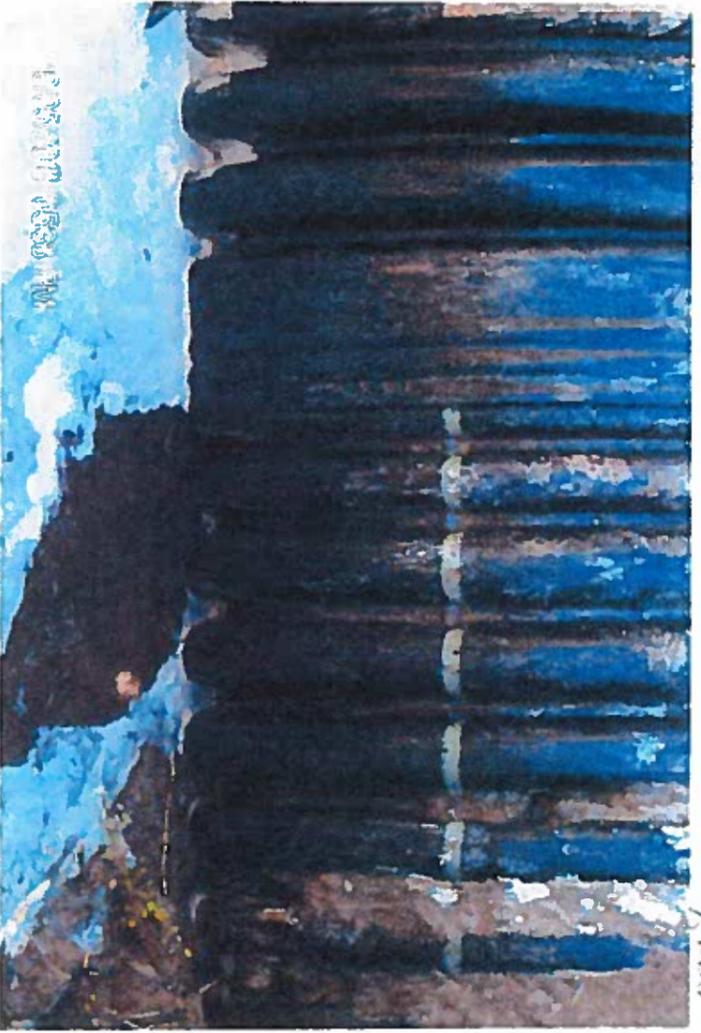
Location #4 - Between Balboa & Magellan. Joint leaking near the bottom of the pipe due to poor pipe connection. Repair will require dewatering.

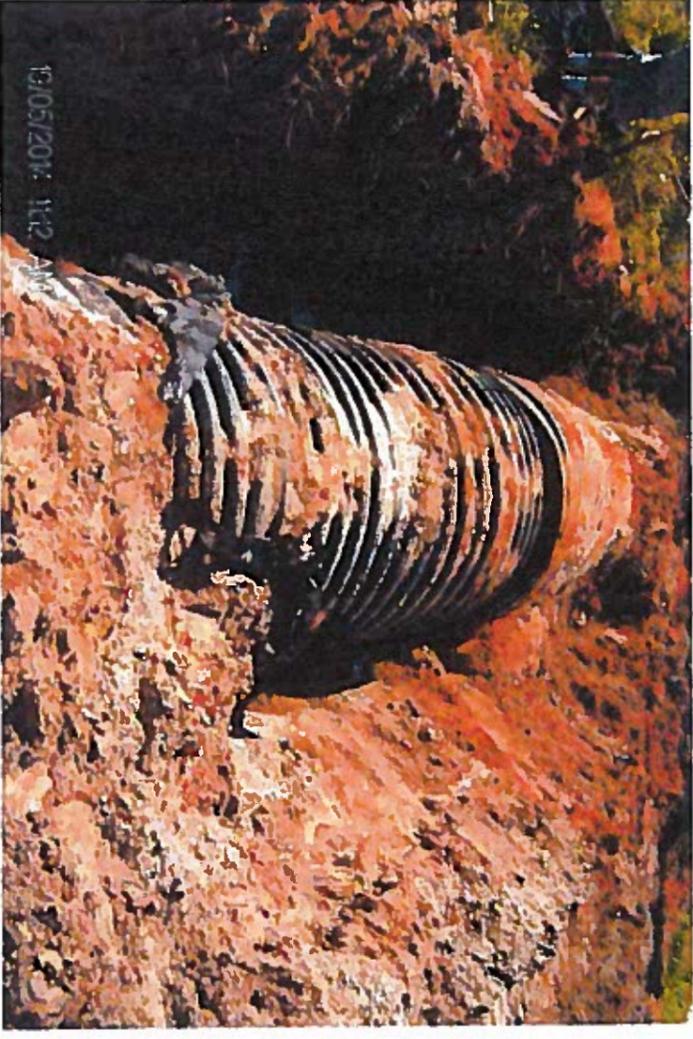
PHOTO #1

Repair location #5 had previously been back-filled by Gulf County Public Works with clay. This location is between Balboa and Magellan St. running parallel to Americus Ave. The pipe is a 48" diameter ADS and is the eastern most of three 48" diameter pipes in parallel. The bell and spigot joint had separated at the top and was exposed. The north end of this section of pipe (repair location #4) had also separated at the bottom of joint. Both connection joints were repaired using Mar Mac Couplers and filter fabric. Four (4) mobile home anchors and tie-down band straps were installed at each joint to stabilize the pipe (see attached pictures for details). Locations where pipe shifting may be a problem, anchor tie downs should be installed.

Location #5 - Approximately 20' south of Location #4 between Balboa & Magellan Street. Joint separated.

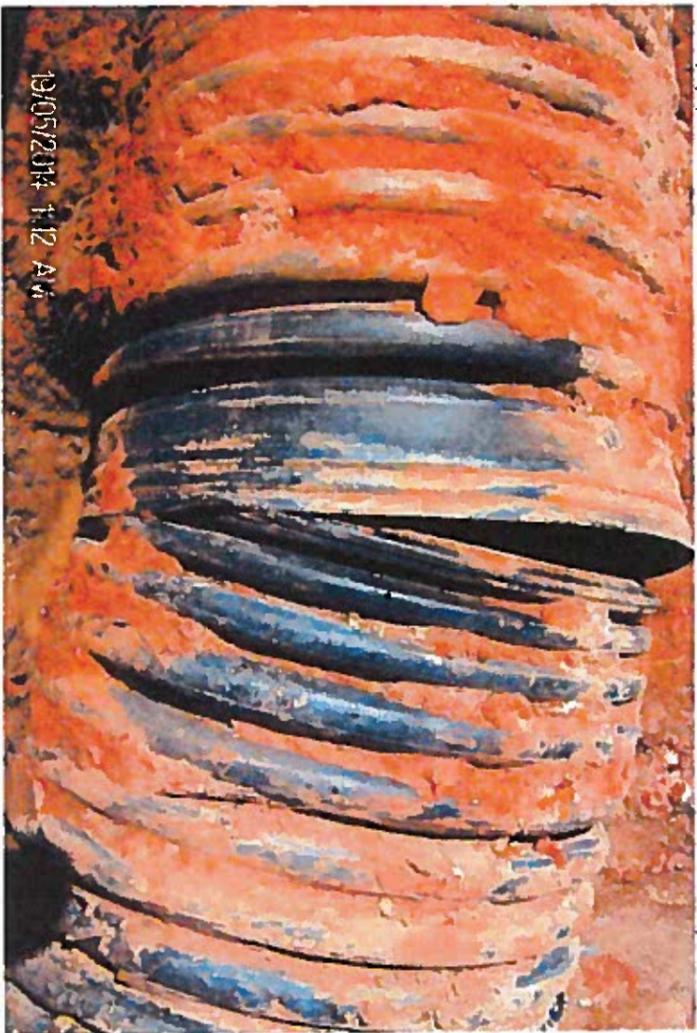
PHOTO #2

Location #5 - side view. Joint separated.

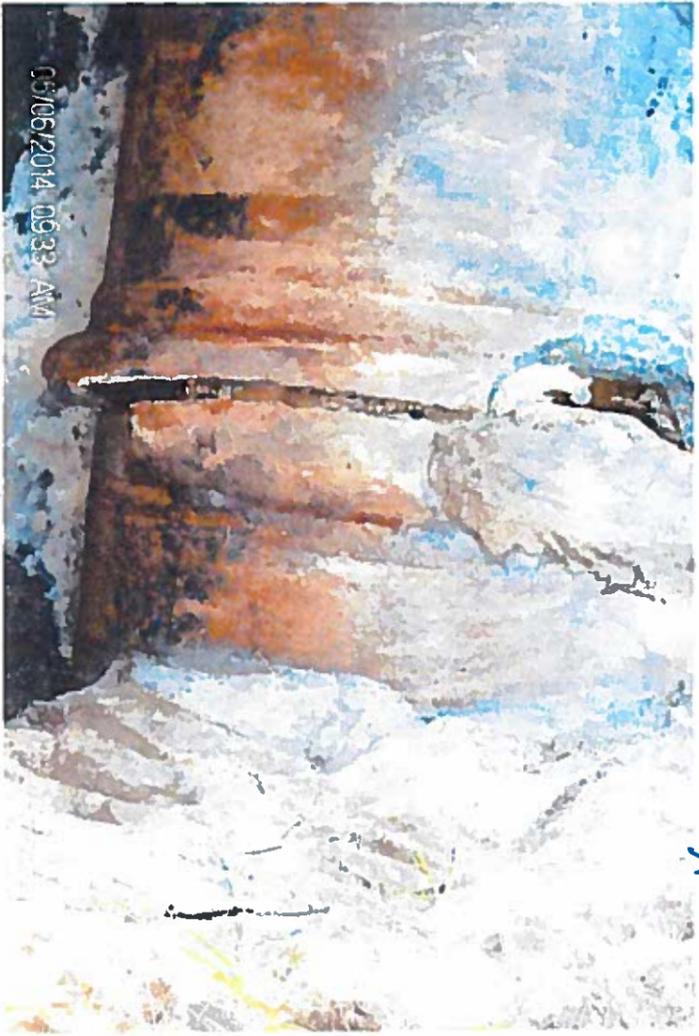
Location #6 - existing 24" RCP joint failure.

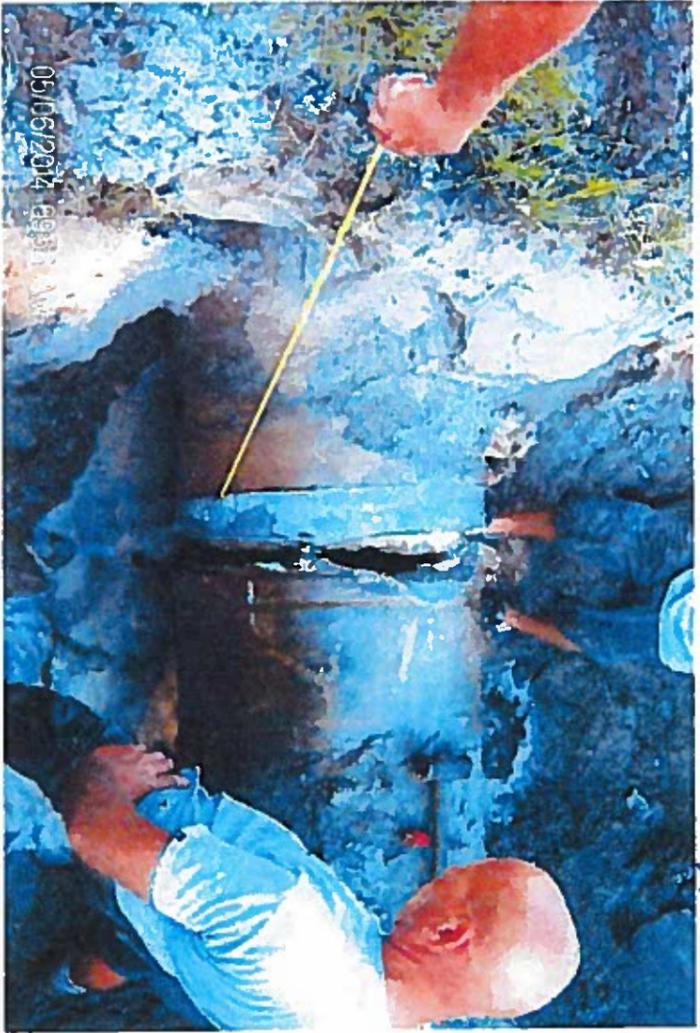
Location #6 - existing 24" RCP joint failure. Excavation complete and joint cleaned.

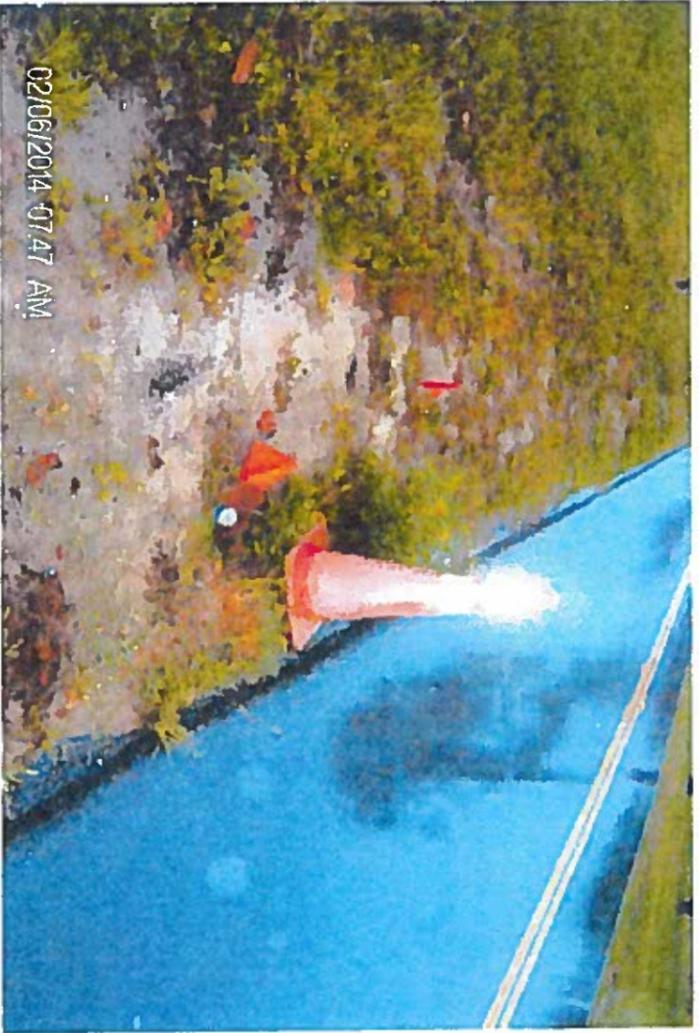
Location #7 - Cross drain between Santa Anna and Gulf Street. Prior to excavation.

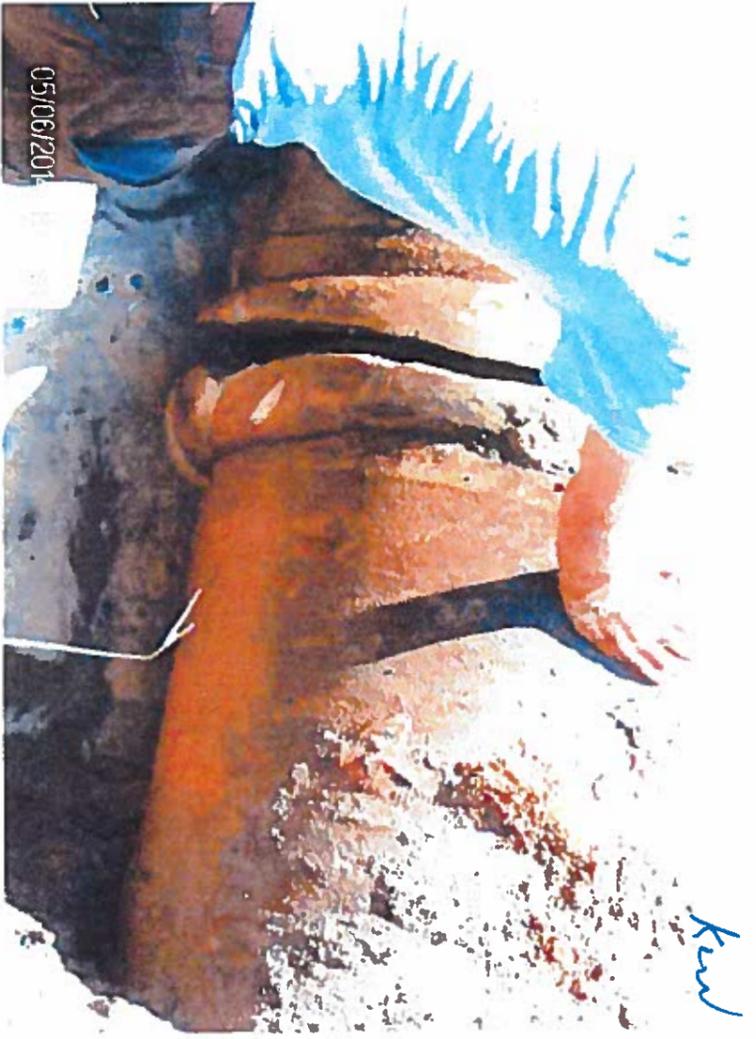
Location #7 - Existing 24" RCP joint failure.

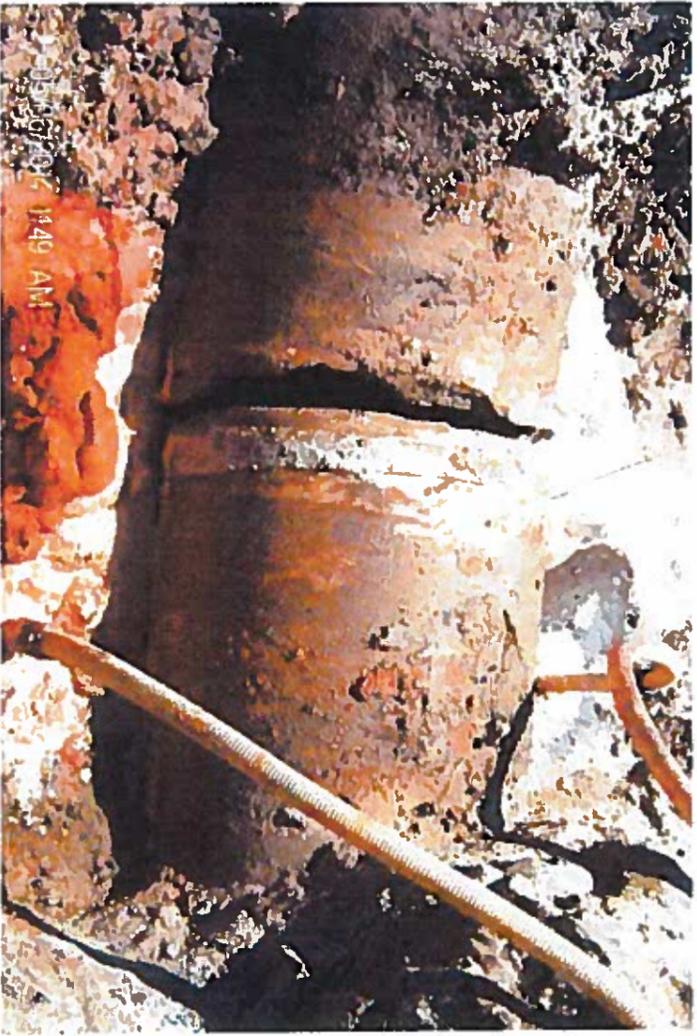
Location #7 - Existing 24" RCP joint failure. Well points for dewatering also shown.

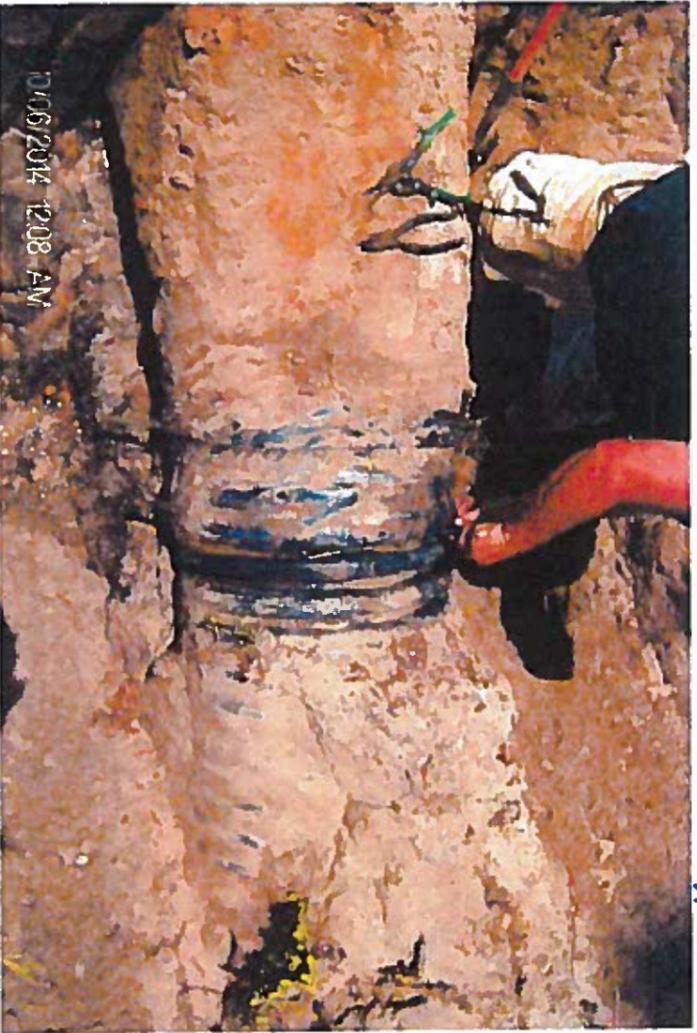
Location #8 - Existing 18" ADS to 18" RCP connection. Removing existing fabric from joint.

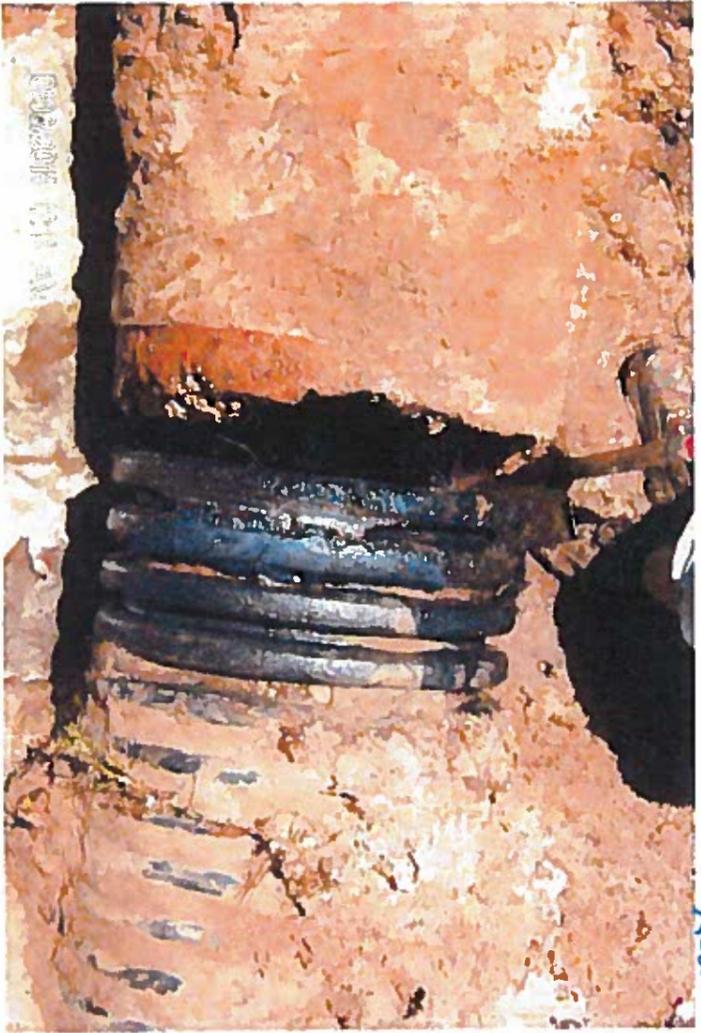
Location #8 - existing 18" ADS to 18" RCP joint exposed.
