**AMERICUS AVENUE DRAIN PIPE
INSPECTION AND REPAIR INFORMATION**

**GULF COUNTY BOARD OF COUNTY COMMISSIONERS
1000 CECIL G. COSTIN SR. BLVD.
PORT ST. JOE, FLORIDA 32456**

PROJECT NUMBER 3.181

Americus Ave. Drain Pipe Inspection and Repair Information

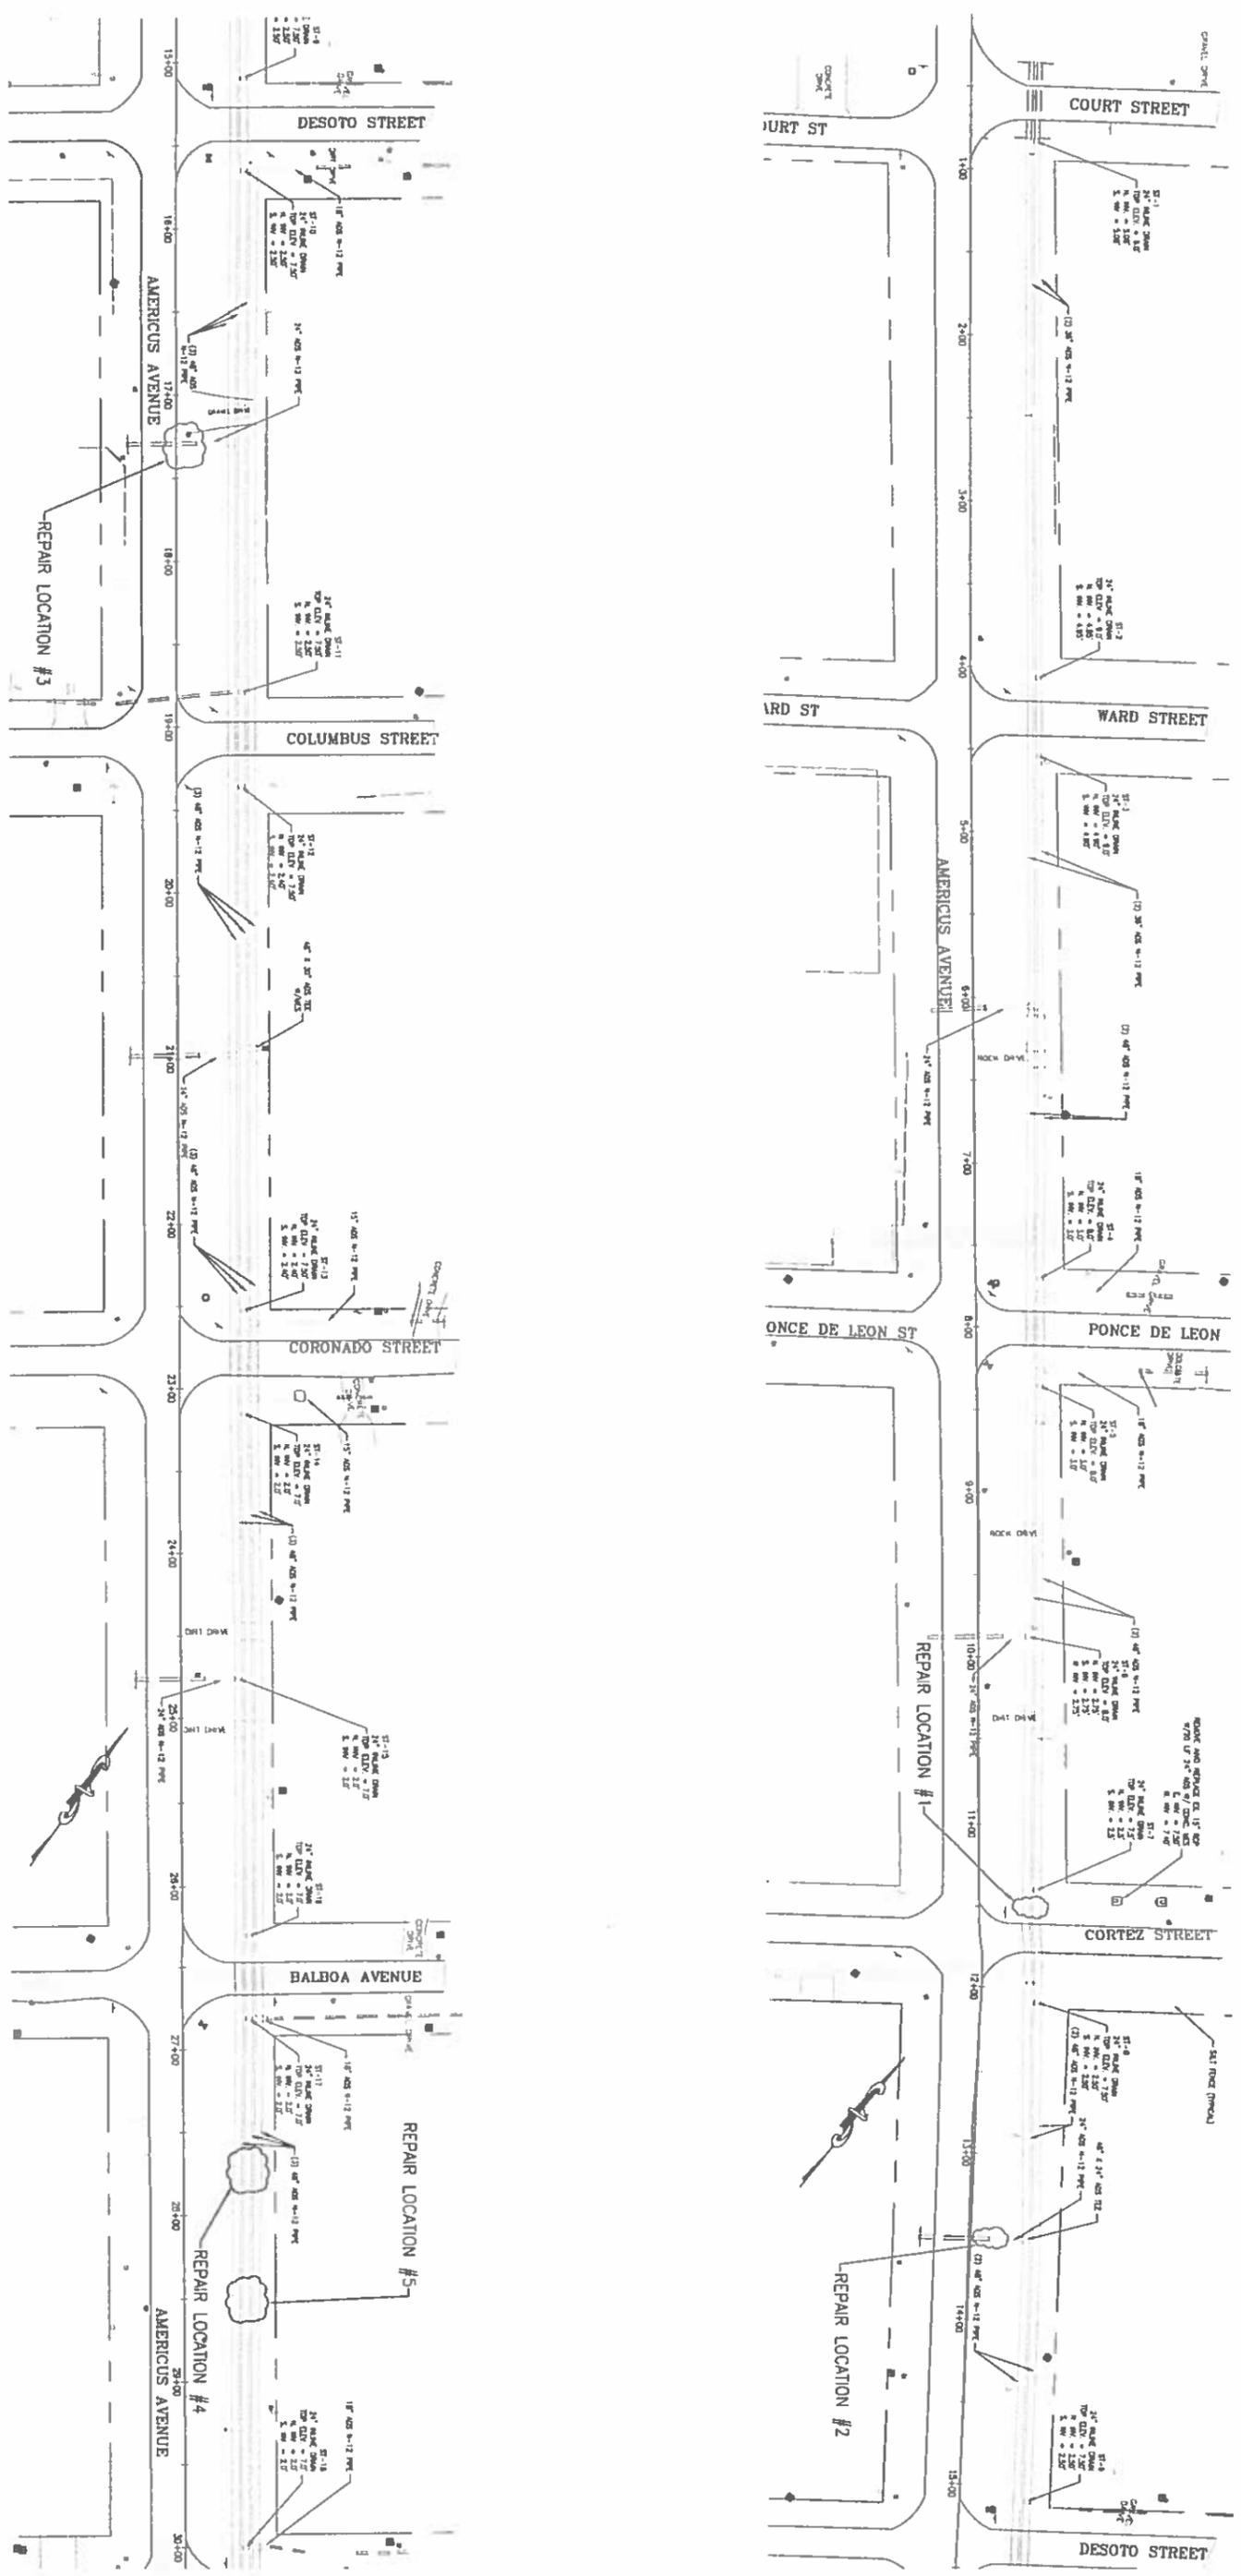
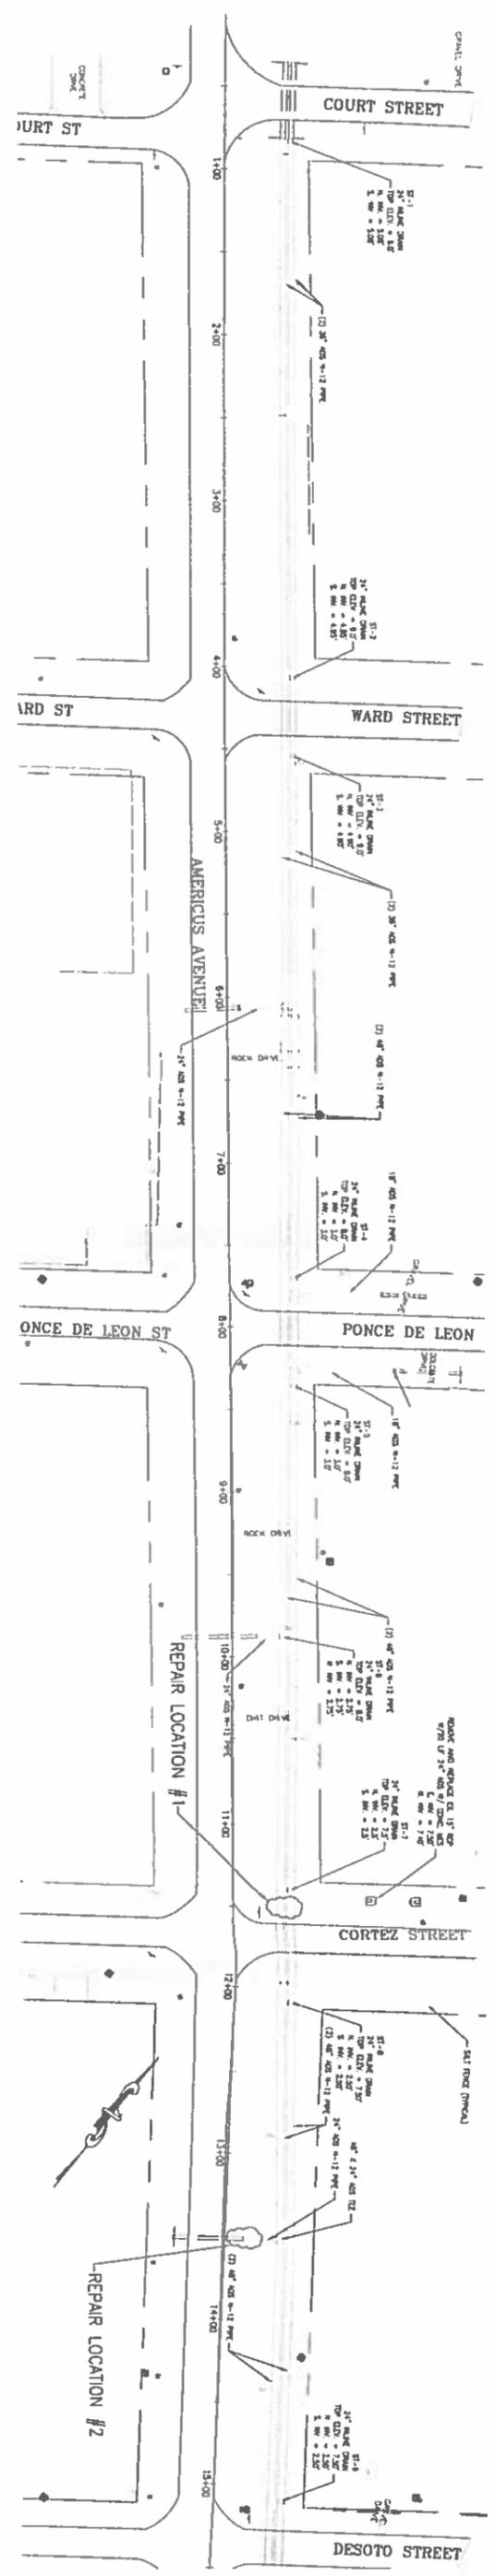
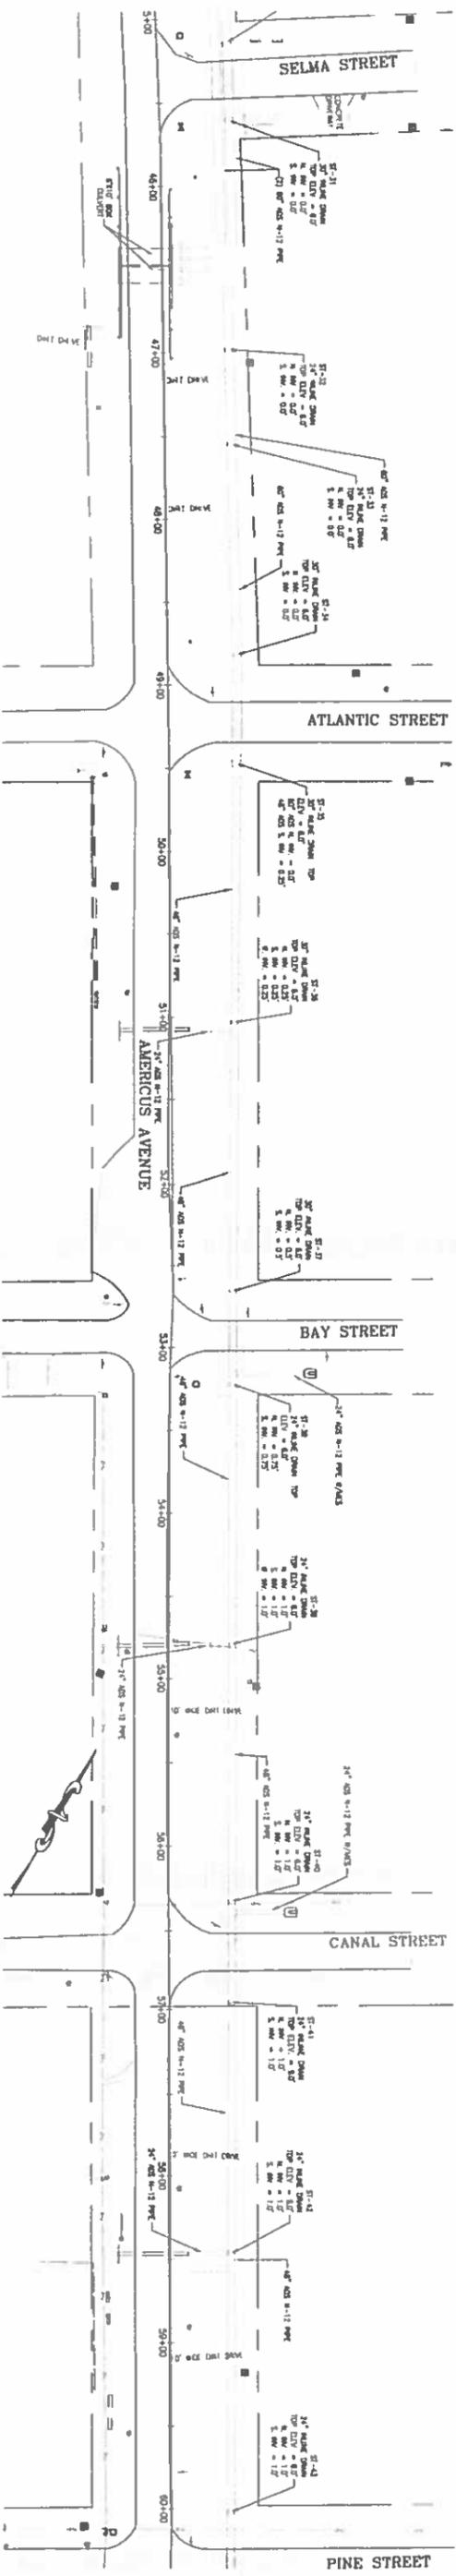
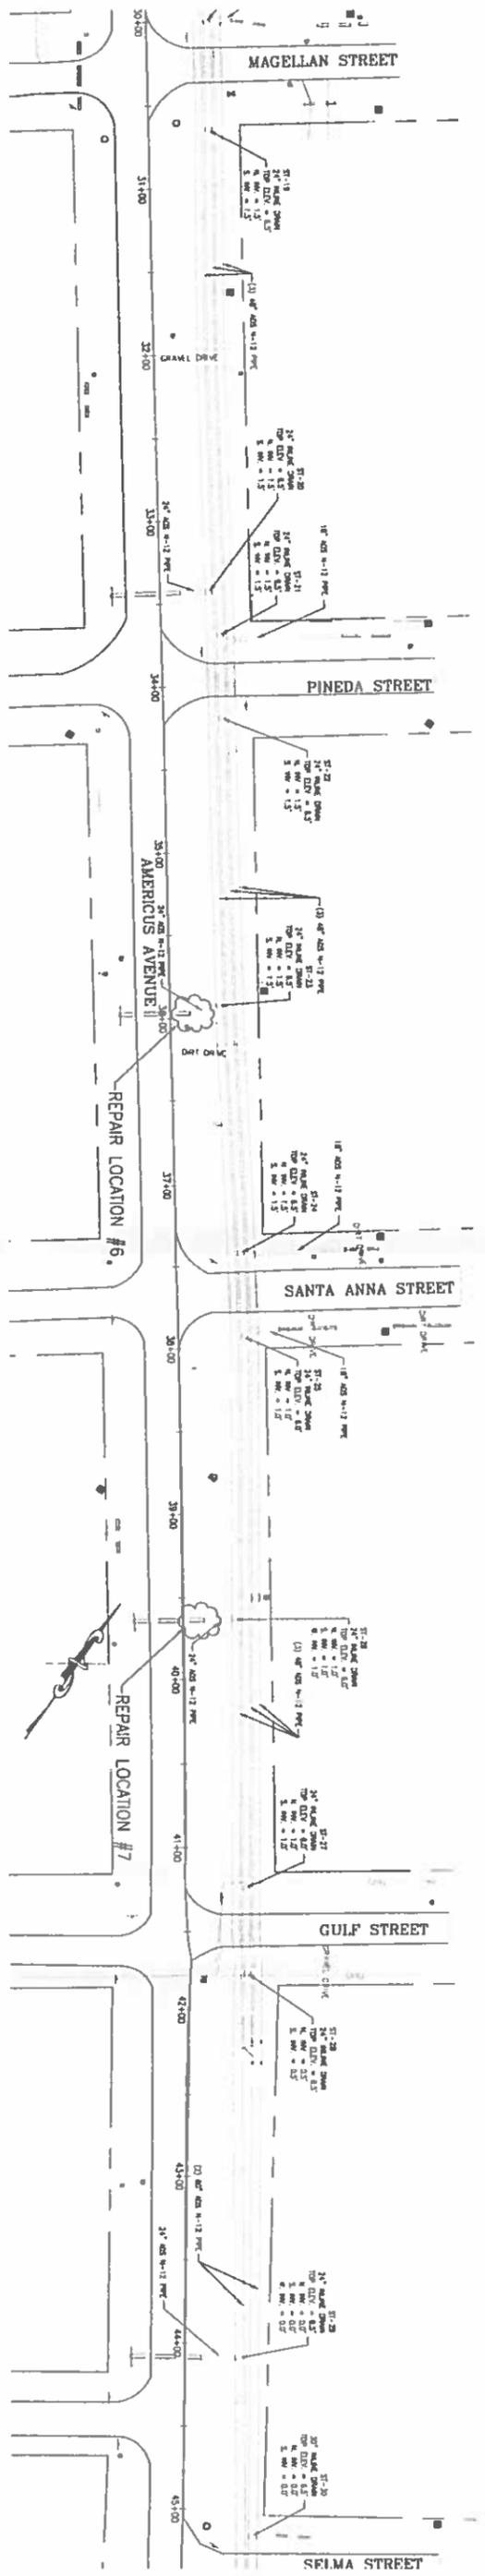
REPAIR LOCATIONS MAP
 AMERICUS AVENUE DITCH
 GULF COUNTY BOARD OF COUNTY COMMISSIONERS

Prior to any future repairs it is advised to refer to the Repair Locations Map (Sheets 1-2) and this report for location details and similar repairs completed.

Repair location #5 had previously been back-filled by Gulf County Public Works with clay. This location is between Balboa and Magellan St. running parallel to Americus Ave. The pipe is a 48" diameter ADS and is the eastern most of three 48" diameter pipes in parallel. The bell and spigot joint had separated at the top and was exposed. The north end of this section of pipe (repair location #4) had also separated at the bottom of joint. Both connection joints were repaired using Mar Mac Couplers and filter fabric. Four (4) mobile home anchors and tie-down band straps were installed at each joint to stabilize the pipe (see attached pictures for details). Locations where pipe shifting may be a problem, anchor tie downs should be installed.
